## Detection of Voids in a Concrete Slab

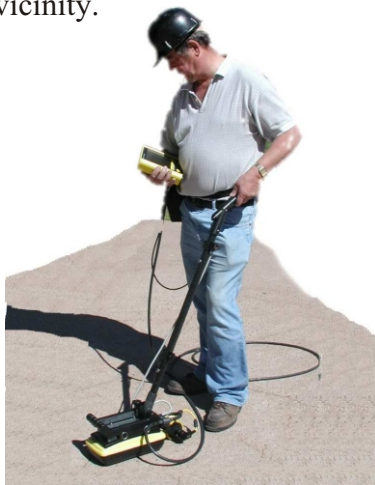
Figure 3. GPR in use

Figure 3 illustrates the ground penetrating radar equipment. It is a highly portable battery operated machine which uses high frequency radio waves similar to a cell phone and consequently poses no health hazard to the operator or anyone in the vicinity.
