## Ground Penetrating Radar Imaging

**Specialists in NDT and Computer Monitoring of Structures**

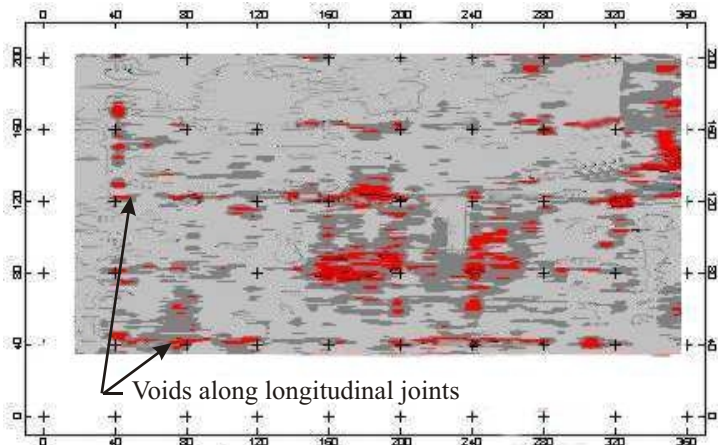
**Figure 1. Two dimensional image of GPR traces at 200 mm below the concrete surface**

The two dimensional image shown in figure 1 is the result of many traverses across a slab-on-grade. The owner required to upgrade the loading on this particular slab and was concerned with the possibility of slab thinning and voids below the slab. The GPR traces, confirmed by cores, revealed a thin section at the centre and that most voids ran along the longitudinal construction joint. The racking was subsequently designed to avoid overloading these locations.

One of the best methods to detect and display the data is to produce a two dimensional image. The methodology involves making many traverses in a strict pattern and analyzing the data as one complete set. This enables slices of the data at selected depth to be produced, highlighting the presence of anomalies within and below the materials.

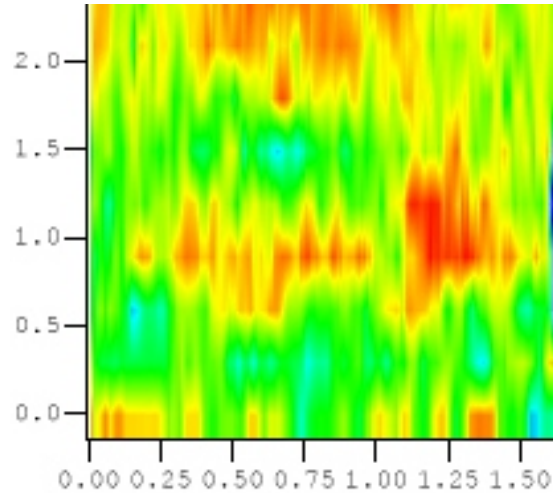
**Figure 2. GPR scan through a stone masonry wall at 500 mm below the stone surface**

An historic masonry structure was undergoing remedial work. A two dimensional image of GPR scans through a stone masonry wall revealed the extent of voids within the rubble area ( figure 2 ).

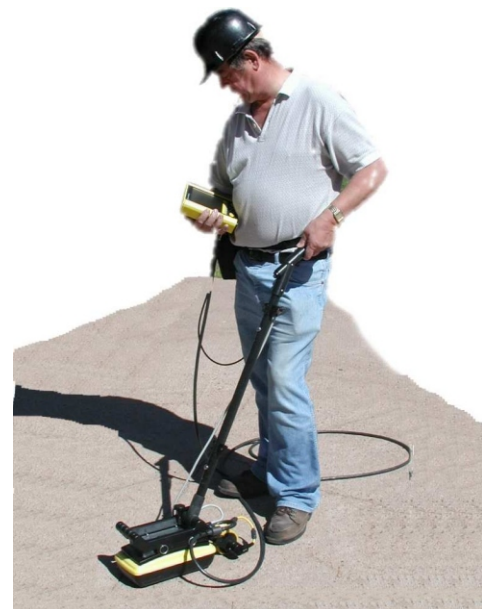
**Figure 3. GPR equipment in use**

Many concrete and stone masonry problems require investigation of potential defects within the materials or below them. Related problems can be assessment of slab thickness, the presence and distribution of reinforcing steel, detecting voids below a slab or behind walls and locating utility pipes within a concrete structure or detecting cables or tanks below a slab. Tekron Services has acquired Ground Penetrating Radar, Noggin 1000 plus to accomplish this task. The equipment is compact, portable and powered by battery

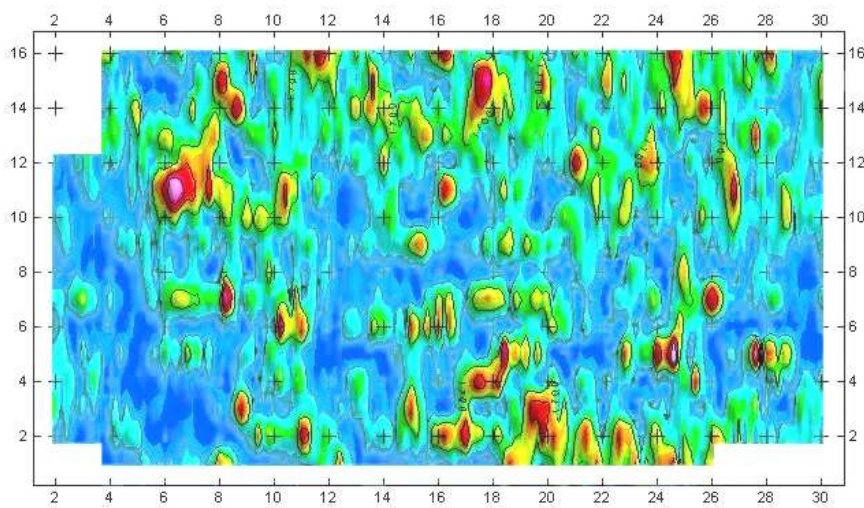
**Figure 5. Two dimensional image of voids in stone masonry wall**      **Figure 6. View of stone masonry wall**

An evaluation of the inner condition of a stone masonry wall was required, during the restoration of an historical building. Linear traverses were made across the wall using ground penetrating radar. Two dimensional images were then prepared of slices through the data which revealed that there was significant voiding (red, yellow, green) in the rubble between the withes of the stone masonry. To stabilize the wall, the centre core was injected with foamed grout through ports drilled into the mortar joints.
